Use Attainability Analysis

WBID 2572 Lick Creek

Submitted by  
SES Inc.

Missouri Department of Natural Resources  
Water Protection Program

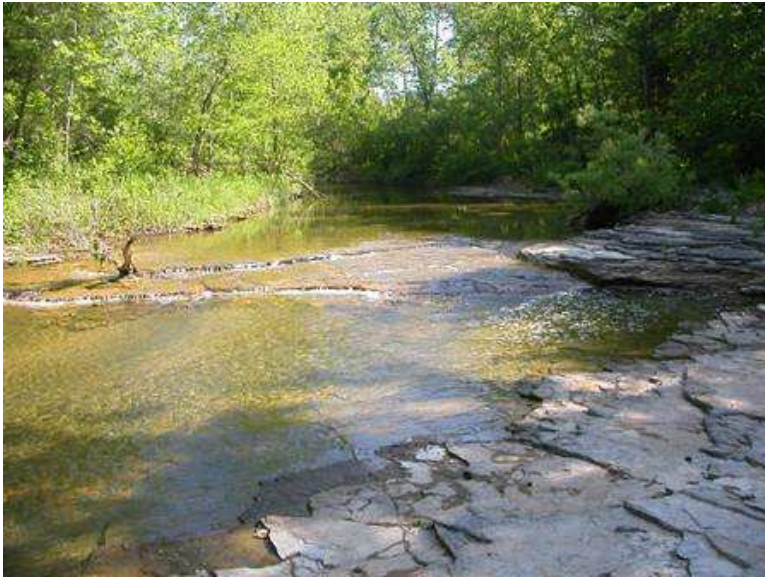
**Site# 1 Photo ID# 80, Upstream**

15% Cobble	15% Gravel	0% Sand	35% Silt
------------	------------	---------	----------

0% Mud/Clay	35% Bedrock
-------------	-------------

Vegetation along banks, little algae covering rocks, and no floating algae present

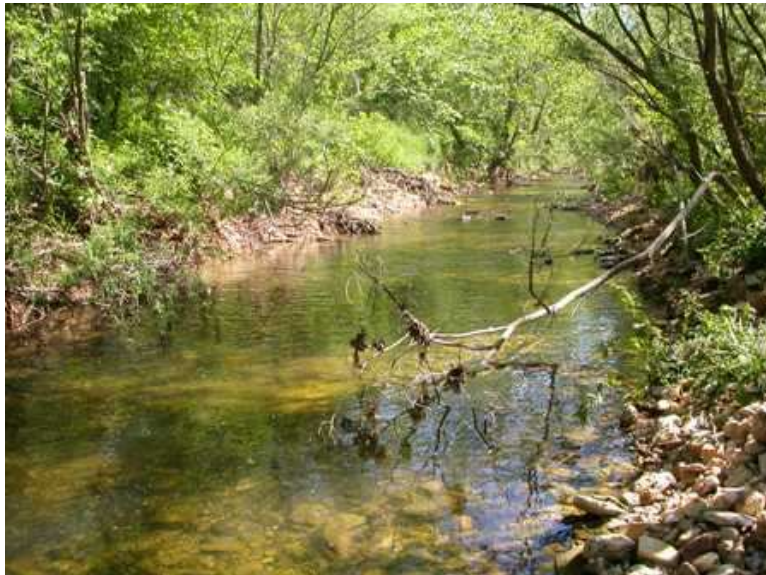
**Site# 2 Photo ID# 82, Upstream**

35% Cobble	35% Gravel	0% Sand	20% Silt
------------	------------	---------	----------

0% Mud/Clay	10% Bedrock
-------------	-------------

Vegetation along the banks, little algae covering rocks, and no floating algae present

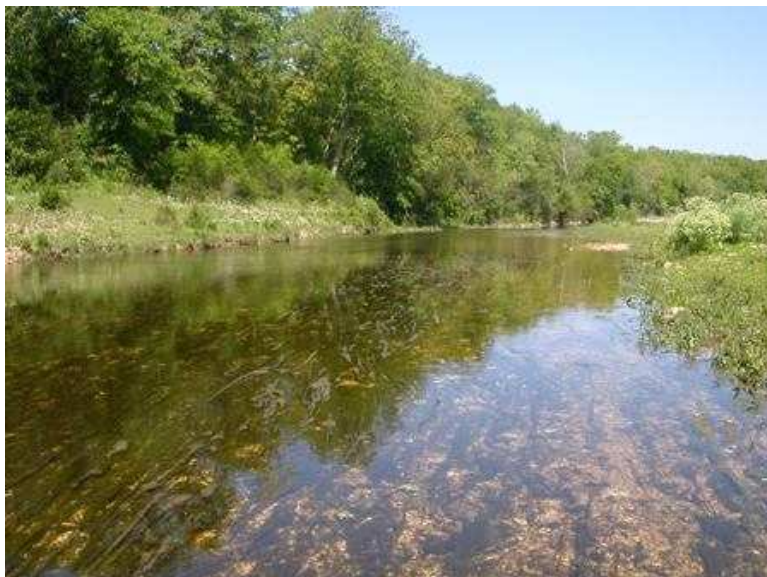
**Site# 3 Photo ID# 84, Upstream**

35% Cobble	35% Gravel	0% Sand	30% Silt
0% Mud/Clay	0% Bedrock

Vegetation along banks, no floating algae present, little algae covering rocks, lots of filamentous green algae, and scattered areas of aquatic grasses.
